Appendix A. Site Photos

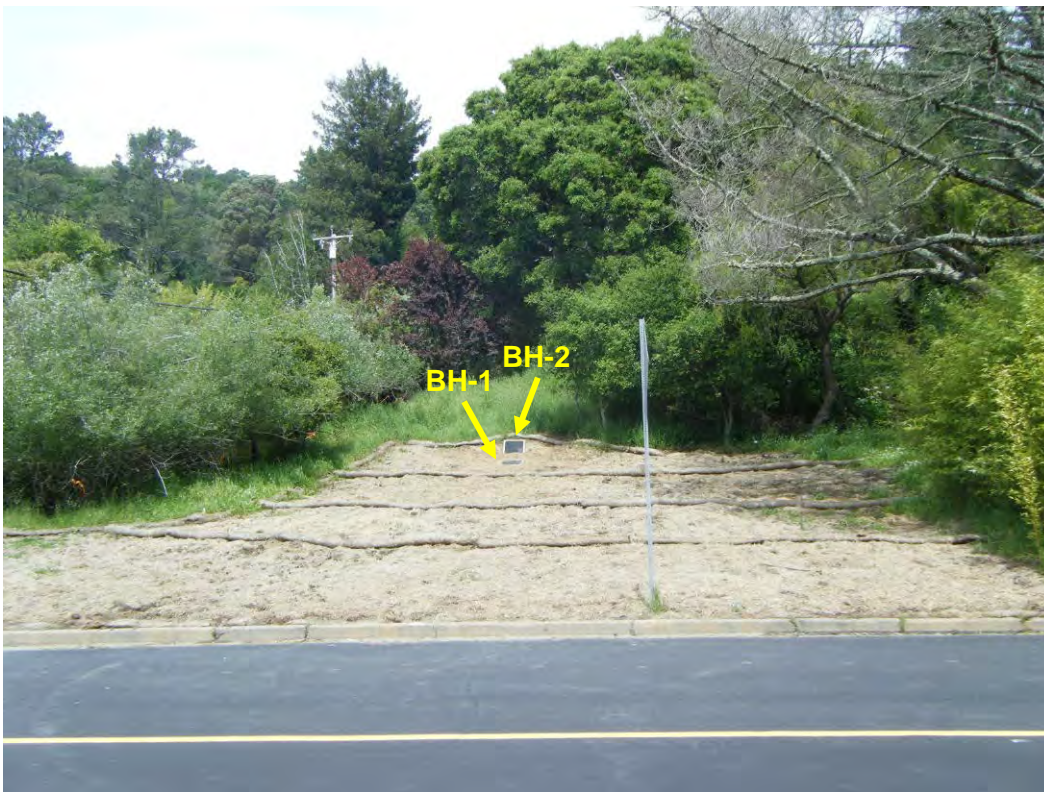
Photo 1. Location of Investigation at the Underhill site after restoration.

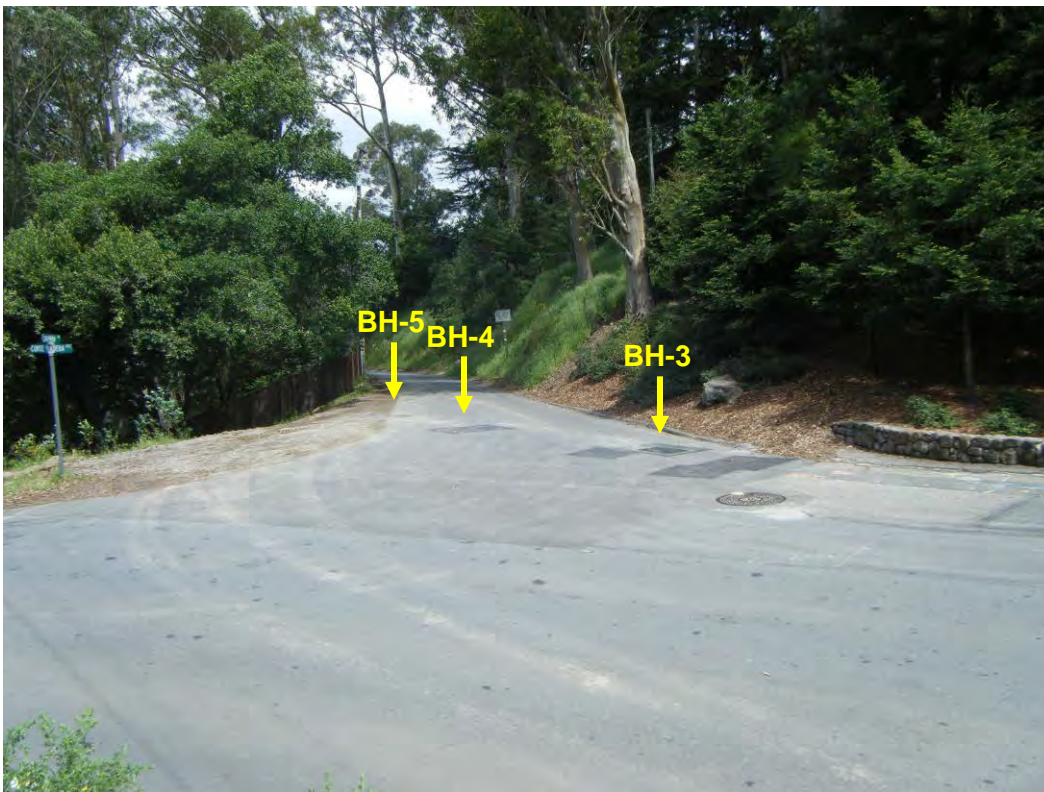
Photo 2. Location of investigation at Chapman site after restoration.

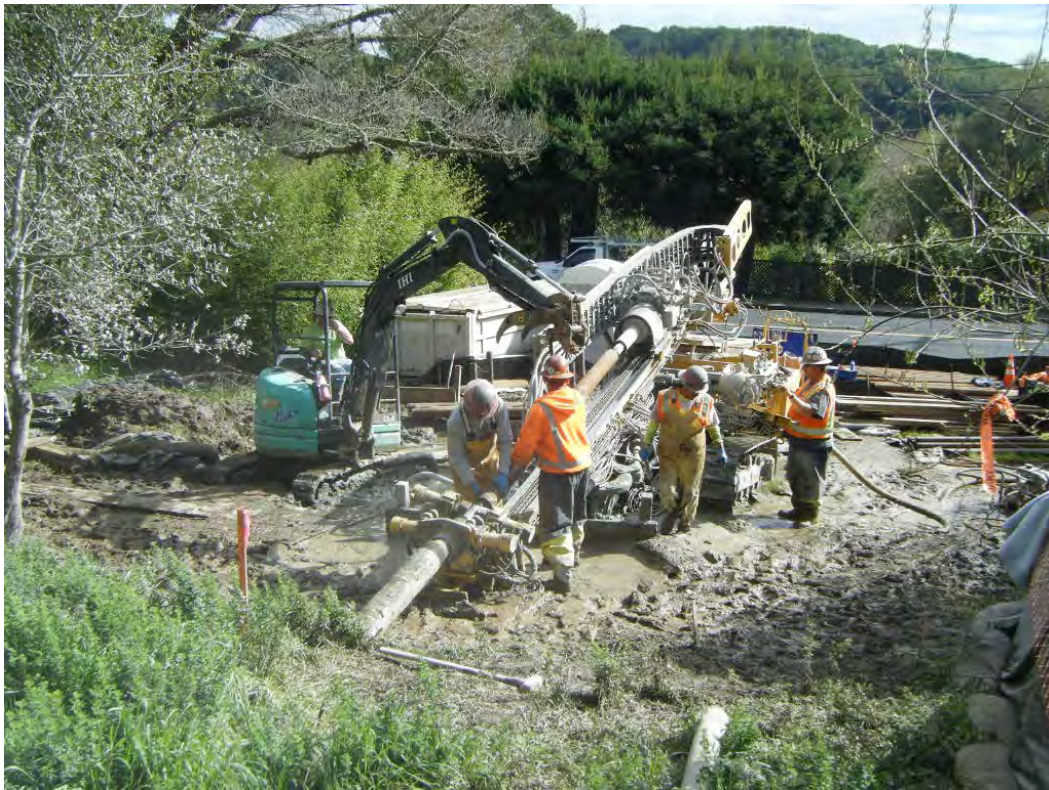
Photo 3. Klemm drill being utilized for the borehole drilling of BH-2 at the Underhill Site location.

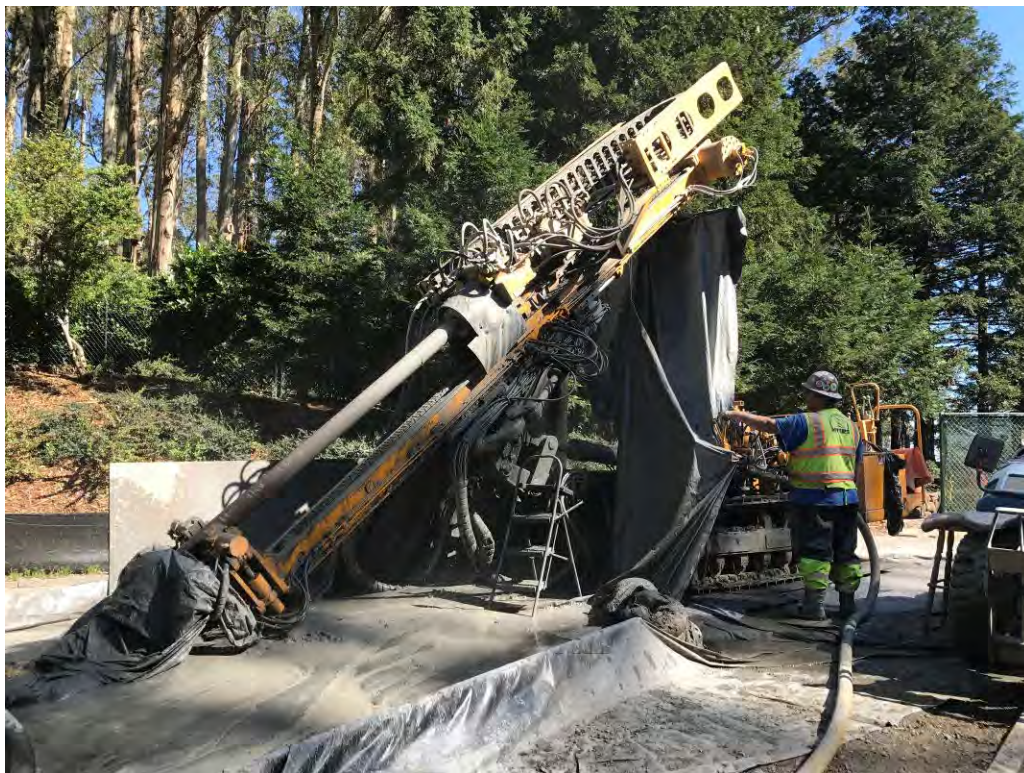
Photo 4. Klemm drill being utilized for the borehole drilling of BH-3 at the Chapman Site location.

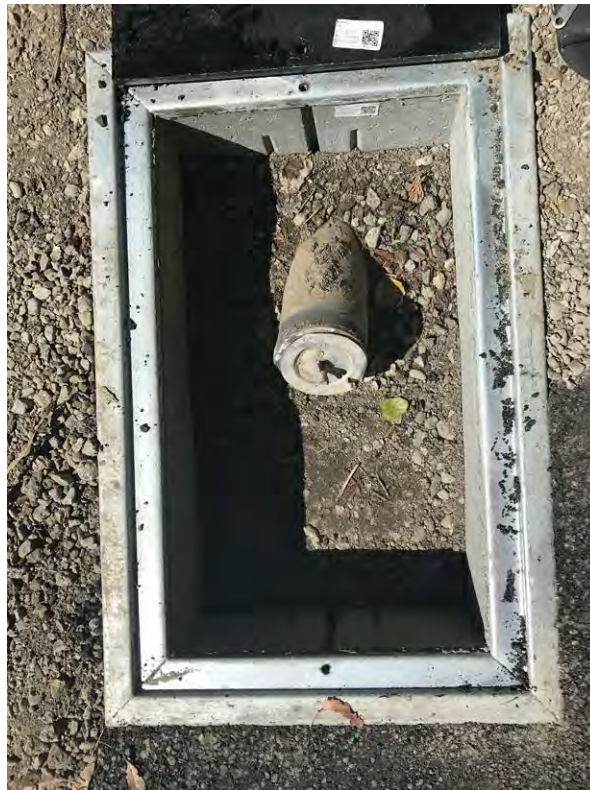
Photo 5. Typical concrete Christy box installation to seal each borehole following the investigation.

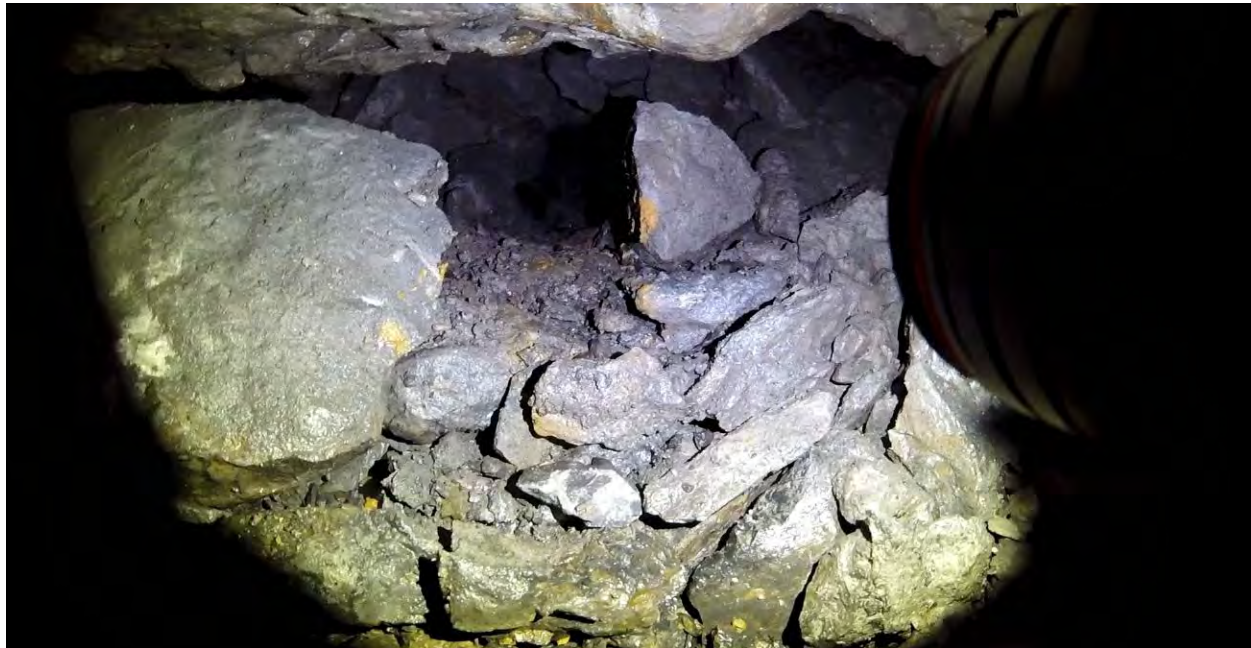
Photo 6. View of bottom of Borehole B-1 showing void area filled with collapsed material.

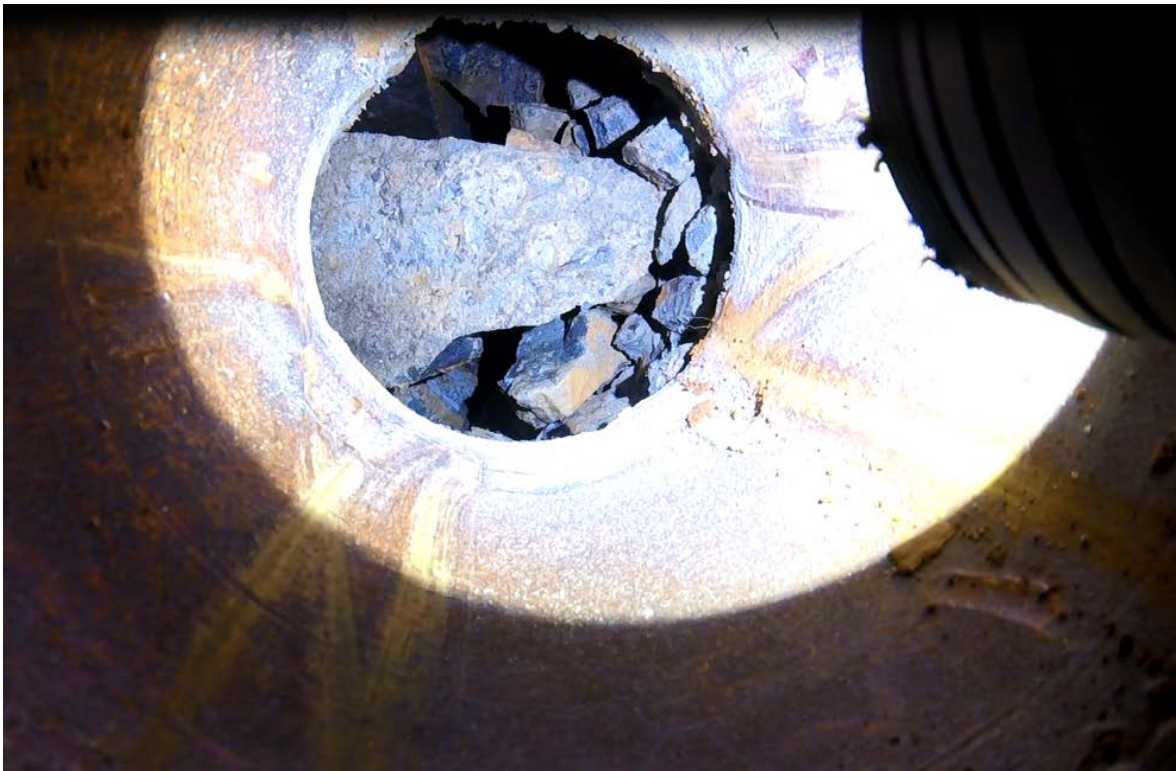
Photo 7. View through bottom of casing of Borehole B-2 showing void area filled with collapsed material.

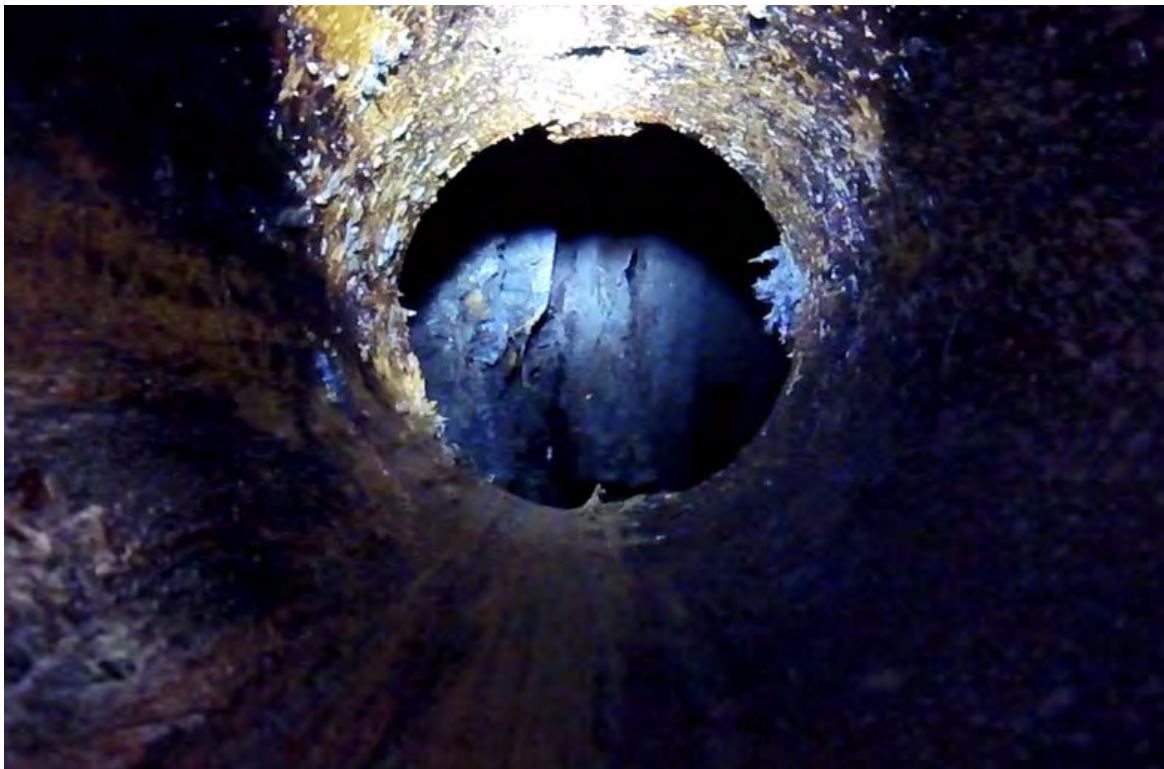
Photo 8. View through bottom of casing of Borehole B-3 showing fibrous wood debris.

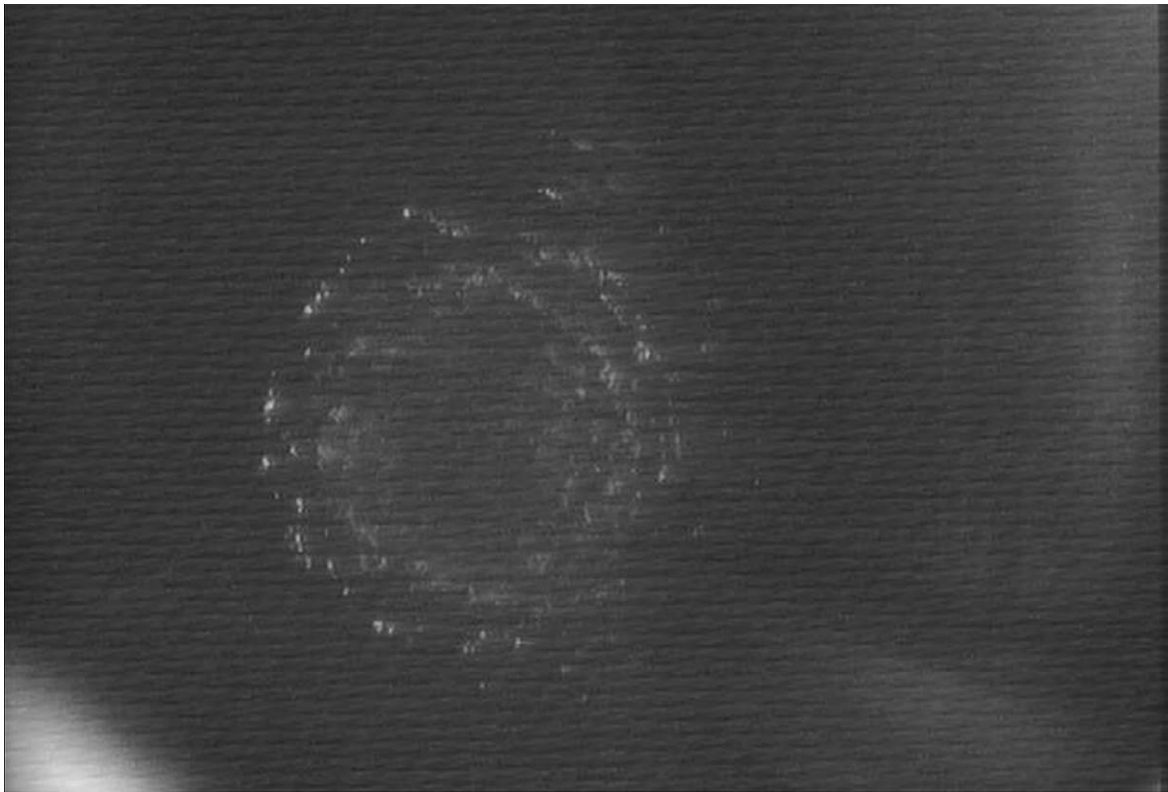
Photo 9. View of bottom of Borehole B-4 showing cavity and rings from water droplets.

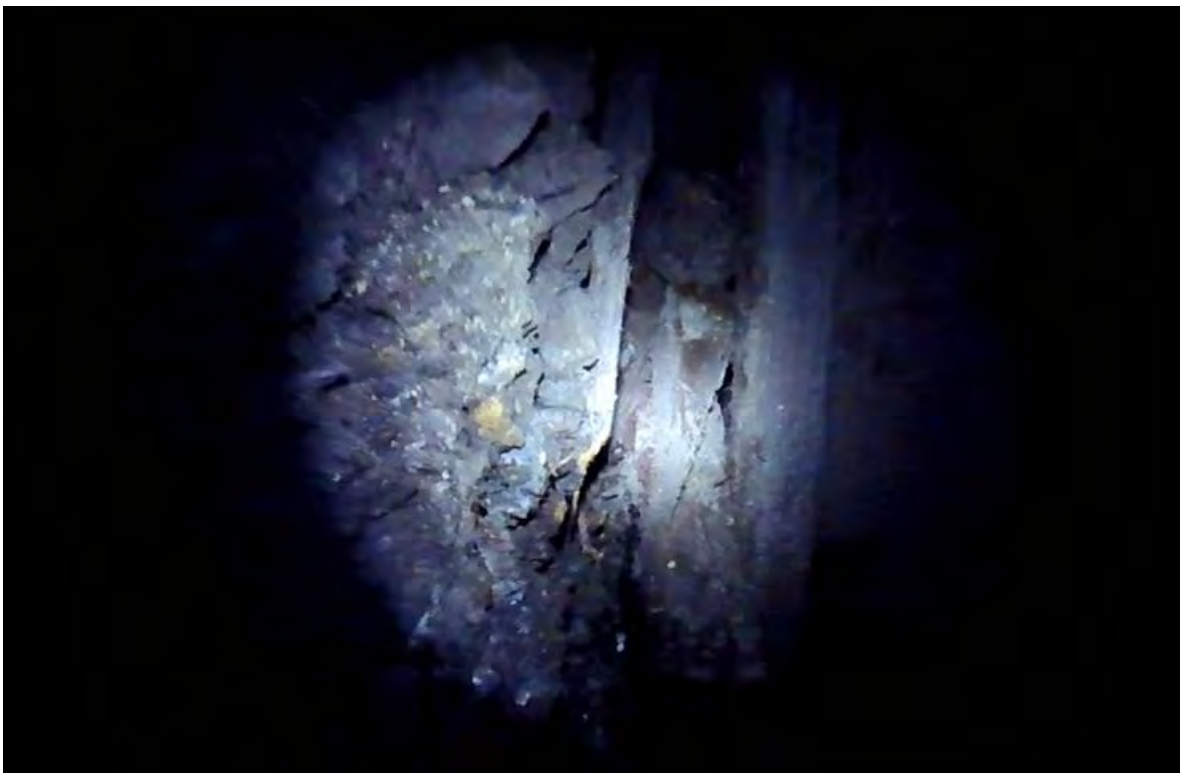
Photo 10. View of bottom of Borehole B-5 showing fibrous wood debris.

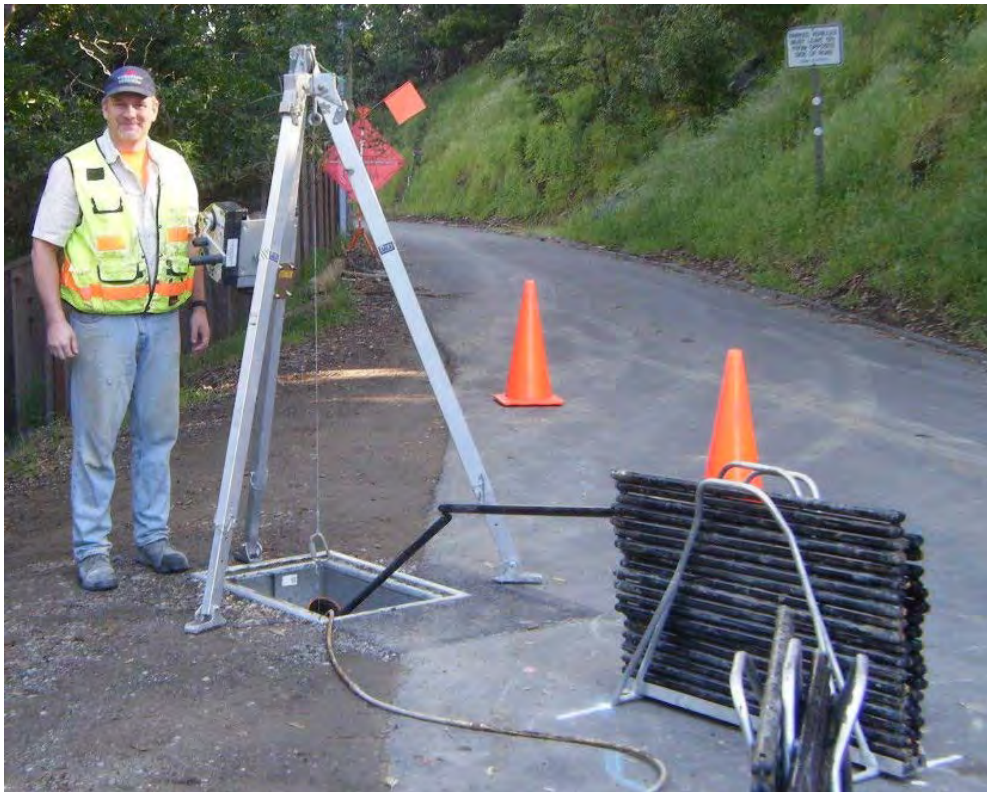
Photo 11. Renishaw was on-site for deployment of the cavity and tunnel scanning equipment.
