*Draft*  
**Alto Tunnel  
Scoping Study**

**Volume II – Engineering Summary and Proposed  
Supplemental Investigation**

Prepared For:  
**Marin County**  
**Department of Public Works**

Prepared By:  
**Jacobs Associates**

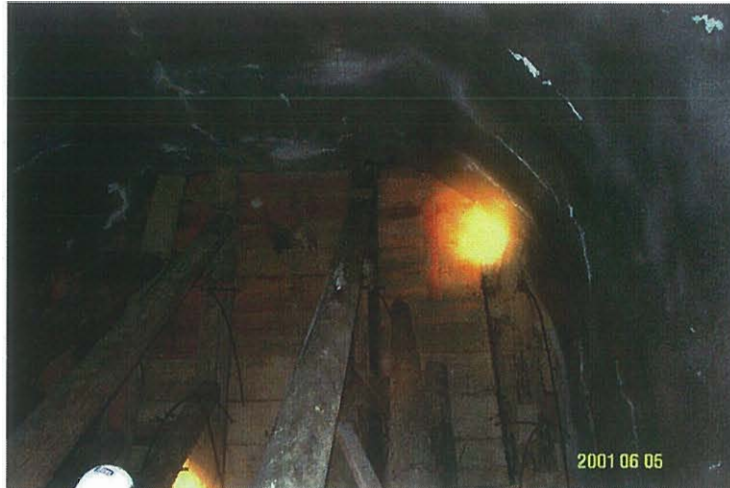
**Figure 2-1. Timber Bulkhead at Face of Concrete Plug**

Approximately 170 feet from the face of the North Portal is the beginning of a concrete plug. According to NWP drawings (Plan Ref. No. 7), the plug is 124-feet long. The Northern end of the plug face is currently covered by a timber bulkhead that consists of horizontal planks (used as the form for the end of the plug) braced by a series of wooden kickers (utility pole size). The bulkhead appears to be intact and is shown below in Figure 2-1:

The base of the bulkhead and kickers was not visible due to the standing water in the invert of the tunnel. There are a number of 3 to 6-inch diameter steel pipes visible in Figure 2-2 which protrude from the center-top of the bulkhead. These pipes were probably used to pump the closing portion of lean-mix concrete behind the bulkhead.

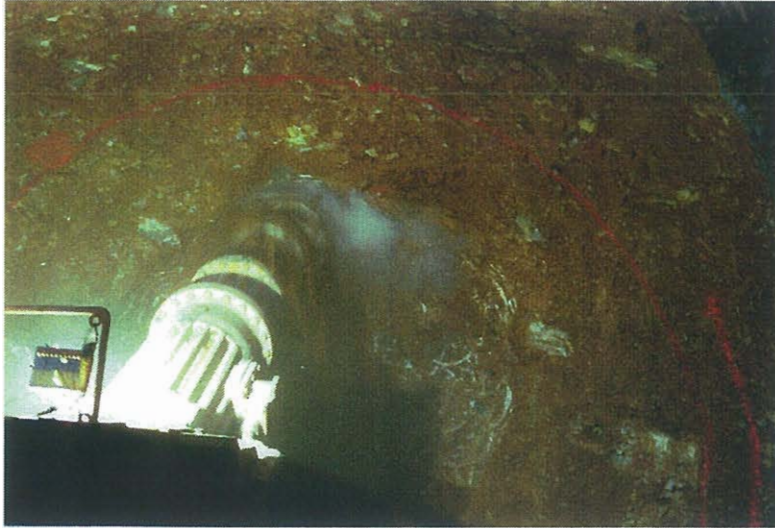
**Figure 3-2.** Roadheader Excavation in 3,000 psi Rock in Napa County

Most roadheaders can excavate rock with an unconfined compressive strength of 10,000 to 15,000 psi. They are most efficient in rock with strength of less than 5,000 psi, but can cut rock from 22,000 to 30,000 psi for a limited duration, depending on the power of the roadheader. Based on a review of construction records, it is anticipated that the 124-foot long lean-mix concrete plug placed at the north end of the Alto Tunnel would exhibit strength of approximately 700 psi, and thus would be easily excavated by a roadheader. A photo of a roadheader excavating 3,000 psi rock in Napa County is shown in Figure 3-2.

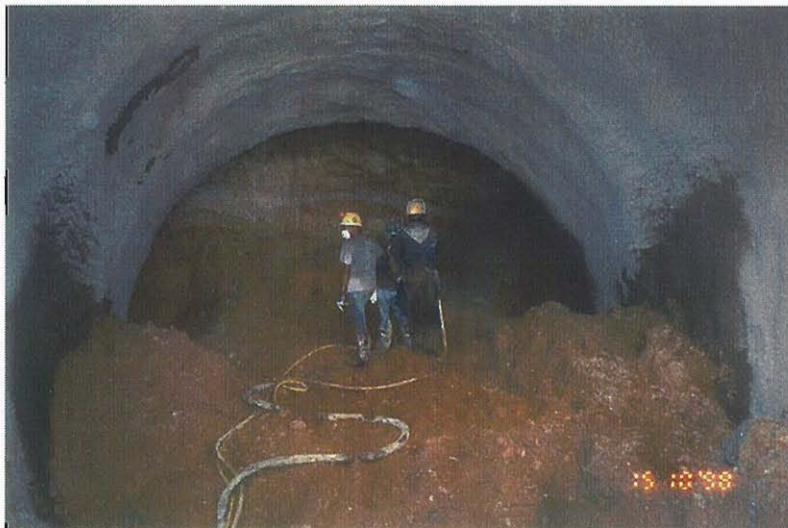
Figure 3-3. Typical Shotcrete Application in Tunnels

Due to access restrictions at the north portal, it is likely that dry-mix shotcrete would be used for support in the exploratory tunnel, as dry-mix concrete can be batched on site as needed. Wet-mix shotcrete would require a larger batch plant on site or could be delivered by ready-mix concrete trucks, however this would require foreknowledge of any supplemental support requirements, a condition that may not always be detected by probing ahead of the excavation.

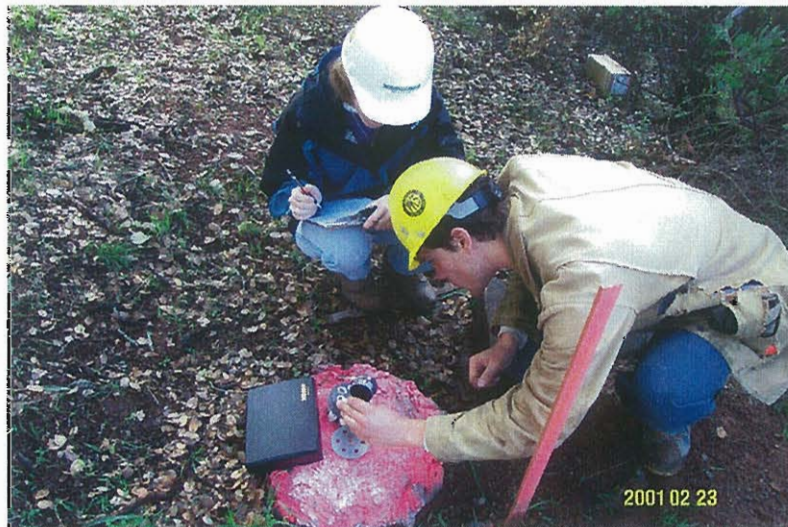
Figure 4-1. Monitoring of MPBX Over a Tunnel

Subsurface ground movements are most accurately and economically measured with Multiple Point Borehole Extensometers (MPBX). These devices are fixed borehole extensometers that measure the changing distance between an anchor point within a borehole and a reference point, usually the collar at the top of the borehole. The distance measured between the anchor point and the reference point is a relative distance, but absolute movements can be measured if the location of the extensometer reference point can be determined with respect to a fixed reference point. These types of extensometers are usually composed of steel or fiberglass rods that do not require movable probes for measurement of movements. Often several fixed borehole extensometers are installed in a single borehole at various depths, as shown on Drawing SK-4. These types of MPBX's can be grouted into small bore holes drilled from the surface, and are easily read using a digital caliper, as shown in Figure 4-1.

The advantage of multi-point monitors is that they can detect movements closer to the crown of the excavation, often prior to any detection at the surface. If excessive movements were detected, then excavation could be halted and the situation evaluated. This would ensure that adjacent properties would not be subject to any significant ground movements.
