## **Appendix B. Tunnel Reconstruction and Permanent Closure Figures**

ALTO TUNNEL INVESTIGATION  
MARIN COUNTY, CALIFORNIA

KNOWN AND INFERRED CONDITIONS

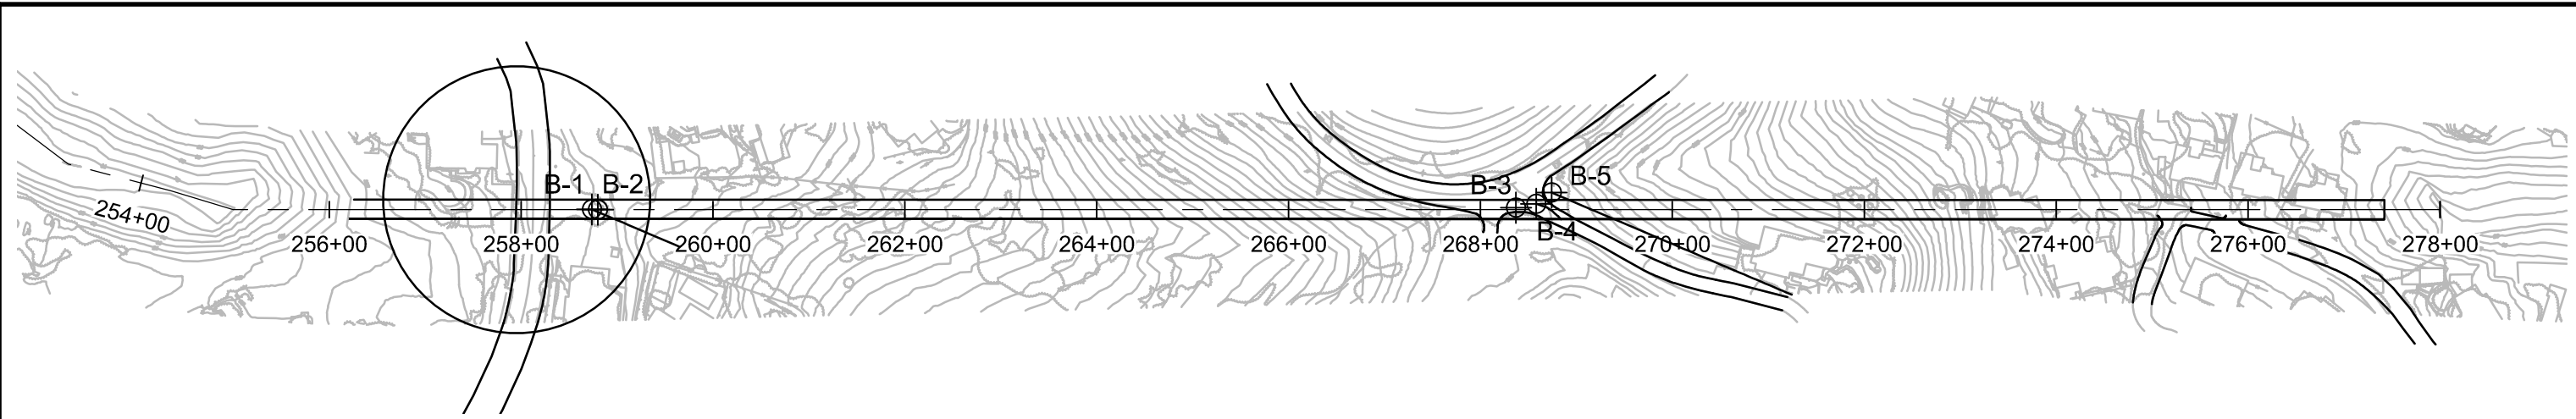
DATE  
SEPT  
2017  
FIGURE  
B-1

NOTE: DISTANCES MEASURED AT CENTERLINE OF TUNNEL.
